Restoration of a Loose Implant Supported Crown: A Case Report

Abstract

Cement-retained, single unit implant supported restorations have become a popular method to treat single tooth edentulous spaces. Occasionally, the clinician is faced with the situation in which the restoration demonstrates mobility. This case report describes the treatment rendered to a patient who presented with a chief complaint of a "loose implant" that had been restored with a cemented PFM crown on a screw retained abutment.

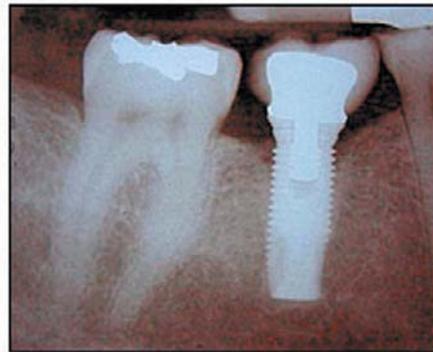
Figure 1. Pre-treatment radiograph.

The patient was a 37-year old male who was referred to our clinic with a diagnosis of a “loose implant.” A review of the dental record revealed the patient had a single tooth implant restoration placed on a Branemark wide platform fixture, Ø5.0 x 13 mm (Nobel Biocare, Gotenborg, Sweden), using a screw retained abutment cylinder (CeraOne 1 mm abutment, Nobel Biocare) in the mandibular right first molar area. No mention was made of the torque used to attach the abutment, or of the type of cement used to secure the restoration. A radiograph was made of the fixture (Figure 1), which appeared to be well integrated with the bone level at the second row of threads.

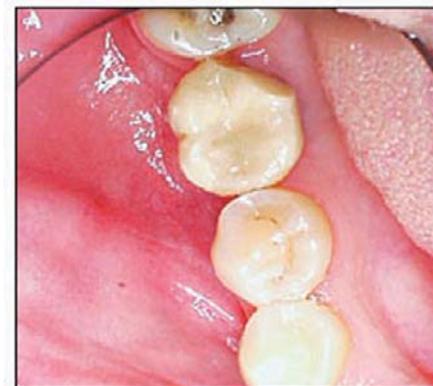
Figure 2. Clinical view of the defective PFM crown.

A clinical exam revealed the restoration was mobile, capable of being rotated about 5 degrees in each direction, as well as being rocked from side-to-side. The patient did not experience any pain or discomfort when the crown was moved. Also of note, the distolingual cusp had fractured off the crown (Figure 2).

According to the patient, this had occurred several months before he began to notice mobility in the restoration. There were no significant periodontal pockets identified upon probing or gingival inflammation associated with the crown.

A tentative diagnosis of a loose abutment screw was made. Impressions were made for diagnostic casts as well as for the fabrication of a custom impression tray. The patient was given an appointment for the following week and was dismissed without any further treatment being rendered. This allowed time to order and receive the necessary components.

Upon his return, the patient reported no change in his symptoms in the intervening week. Since the crown was defective, it was decided to remove it and the abutment as a single unit in order to avoid damage to the internal threads of the fixture, making it unusable for supporting a new abutment or restoration.^{3,7} A high-speed diamond bur with air-water spray was used to reduce the occlusal surface of the crown until the top of the abutment cylinder was exposed (Figure 3). No packing was noted over the abutment screw. The abutment screw was found to be loose. The screw was removed along with the crown-abutment complex. The abutment and crown were firmly affixed to each other, and there was no movement between the two components. The implant fixture was firmly anchored to the bone. The provisional diagnosis of a loose abutment screw was confirmed.

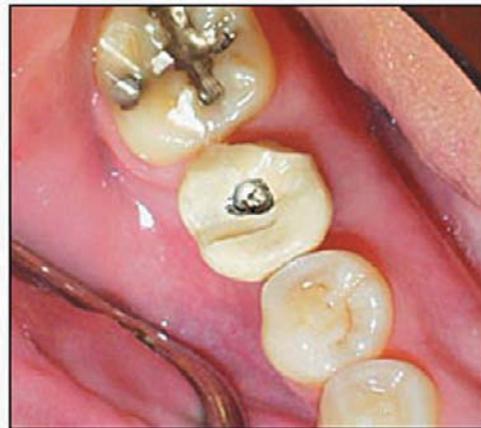
Figure 3. The abutment screw is exposed through the occlusal surface of the PFM crown.

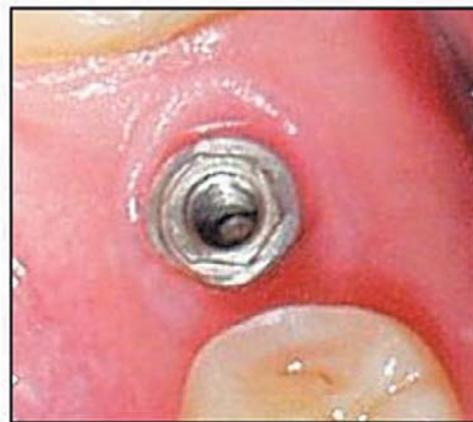
The superior surface of the fixture was evaluated under 3X magnification. Slight rounding of the external hex was noted. This was probably caused by the rotation of the abutment after the abutment screw had come loose. Damage to the external hex has the potential of interfering with the complete seating of a new abutment or with the fit of female internal hex of the abutment (Figure 4).

Figure 4. Note how the movement of the loose restoration has damaged the external hex of the abutment.

A new CeraOne wide platform 1 mm abutment was connected to the fixture with a new gold abutment screw. There was no rotary movement of the abutment when the screw was placed with minimal finger torque. A radiograph was made to verify the abutment was fully seated (Figure 5).

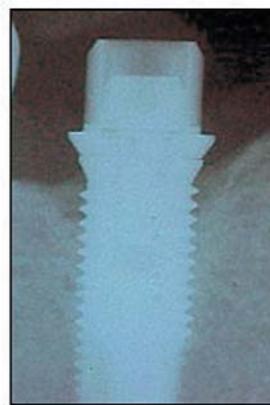
Figure 5. A radiograph is used to verify the complete seating of the abutment prior to applying the final seating torque to the abutment screw.

An electronic torque control handpiece (Nobel Biocare) was used to torque the abutment screw to 45 Ncm. A temporary crown was fabricated using a CeraOne temporary cap, methyl methacrylate resin (Jet Acrylic, Lang Dental Manufacturing Co., Wheeling, IL), and a clear plastic stent (Thermo-forming material, Henry Schein, Inc., Melville, NY). The tissue surface of the crown was shaped to place slight pressure on the gingival tissue in order to achieve a more favorable emergence profile (Figure 6). The patient was given oral hygiene instructions and an appointment for final impressions in two weeks.

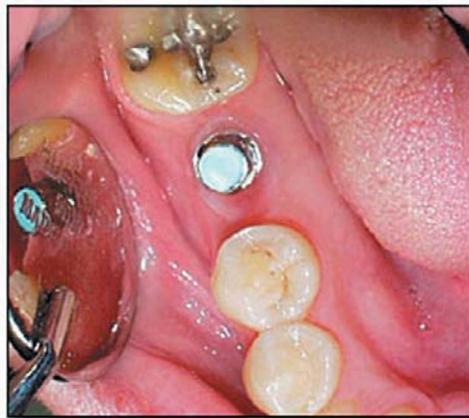
Figure 7. Screw access is sealed with rapid-setting vinyl polysiloxane material.

After two weeks, the patient returned to the clinic for final impressions. The temporary crown was removed, and the abutment was cleaned. The torque of the gold screw was verified with the electronic torque controller, and the access was

sealed with a rapid-setting vinyl polysiloxane material (Blu-mousse, Parkell, Inc., Farmington, NY) (Figure 7).

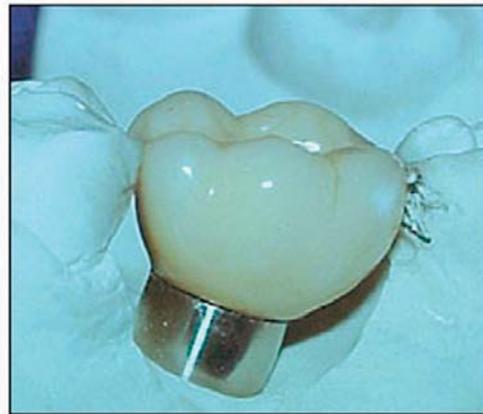
Figure 8. New restoration on master cast.

The final impression, laboratory analog, burnout coping, facebow transfer, and jaw relation records were sent to the laboratory with a laboratory authorization for a porcelain fused-to-metal (PFM) crown. The completed PFM crown fit well on the master cast, having a light centric contact and no contact in lateral excursions (Figure 8).

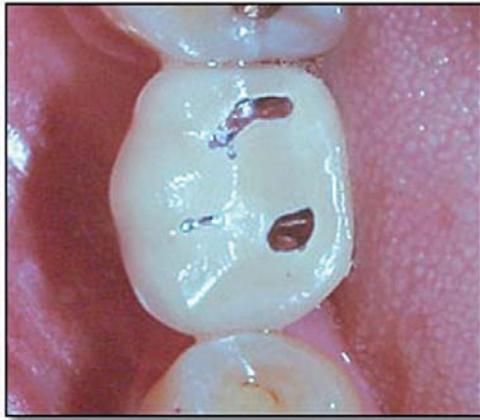
The crown was found to be about 2 mm high when it was tried in the mouth. Since the patient was leaving the area immediately following the appointment, there was no time available to remake the restoration. Therefore, the crown was adjusted intraorally until only a light contact in maximum intercuspation was achieved. The crown was then adjusted so there was group

Figure 9. New restoration after occlusal adjustment completed.

function with lateral guidance on the canine and premolars. This occlusal adjustment resulted in the removal of much of the occlusal porcelain and the exposure of some of the metal substructure (Figure 9). The patient was advised of the situation. Since the patient was not concerned with the display of metal on the occlusal surface, the crown was cemented with Temp-Bond™. For restorations with excellent retention/resistance form, Temp-Bond™ has a similar tensile resistance to dislodgement as zinc-phosphate cement.⁸

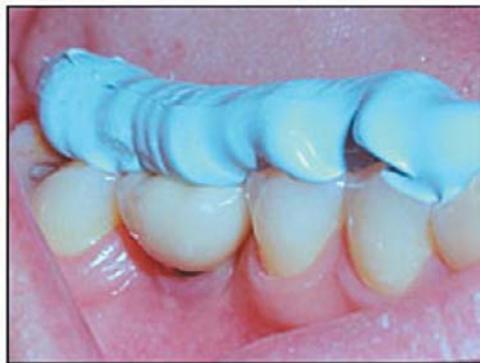
Figure 10. Rapid-setting vinyl polysiloxane occlusal registration.

Prior to cementing the crown an occlusal registration was made with rapid-setting vinyl polysiloxane material (Blu-mousse, Parkell) (Figure 10). The registration and crown were then placed on the master cast. With the crown firmly imbedded in the registration, there was a 2 mm gap between the seating surfaces of the crown and the labora-

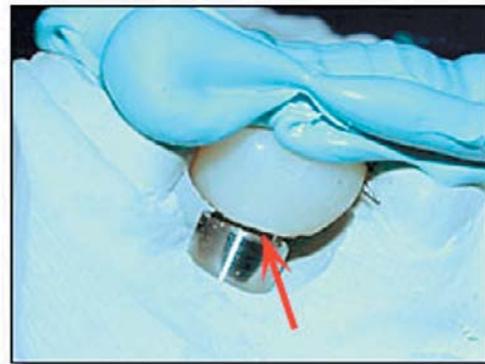
tory analog (Figure 11). There are two possible causes for this error. The most probable cause was the laboratory analog was not fully seated in the impression coping when the master cast was poured. To prevent this type of error the laboratory technician must ensure the lab analog is fully seated in the impression coping (Figure 12).

A second possibility is the laboratory analog vibrated out of the impression coping when the impression was vibrated during the pouring of the cast. This is the less likely scenario as there is significant friction between the parallel surfaces of the impression coping and the laboratory analog. To prevent this from occurring, a small drop of cyanoacrylate cement could be placed on the laboratory analog prior to placing it into the impression coping.

Figure 11. Crown seated on the master cast using the occlusal registration. Note the gap between the abutment and the crown.

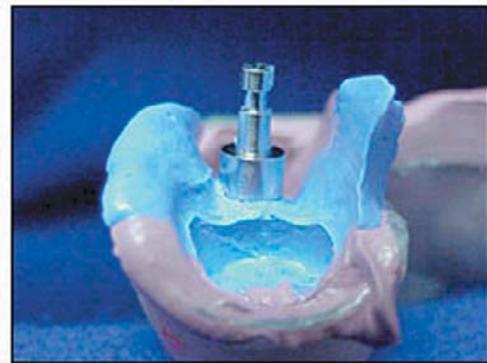
Figure 12. Laboratory analog properly placed in the final impression.
