Load-to-fracture Value of Different All-ceramic Crown Systems

Mark David Snyder, DDS; Kyle Douglas Hogg, DDS

Citation: Snyder MD, Hogg KD. Load-to-fracture Value of Different All-ceramic Crown Systems. J Contemp Dent Pract 2005 November;(6)4:054-063.

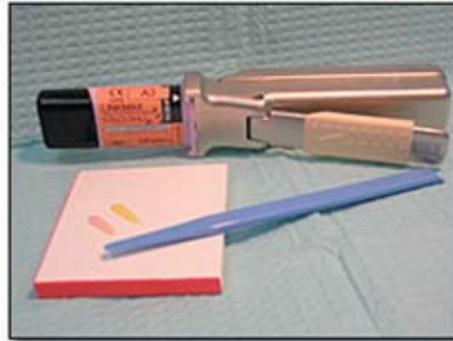
Figure 1. G.C. Link Max resin adhesive cement. (G.C. America Inc., Alsip, IL)

The purpose of this study was to investigate the difference in fracture strength of five different all-ceramic crown systems. The ultimate load-to-fracture strength of the all-ceramic crowns, when luted with G.C. Link Max resin adhesive cement (G.C. America Inc., Alsip, IL), was used as the determining factor for this study (Figure 1).

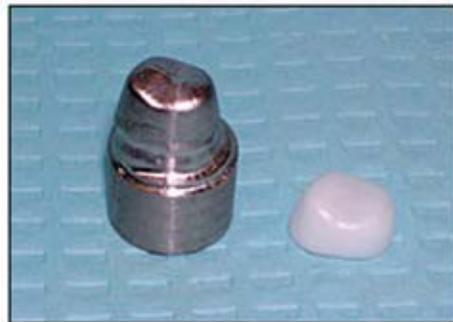
Figure 2. Grade 2 titanium standardized die with corresponding Procera[®] Zirconia coping.

For this investigation, fifty Grade 2 titanium standardized dies, pre-milled to the dimensions of a lower molar crown, were obtained (Figure 2). Twenty of the dies were scanned following the protocol outlined by Procera[®], using CAD/CAM technology (Nobel Biocare USA, Inc., Yorba Linda, CA) (Figure 3).

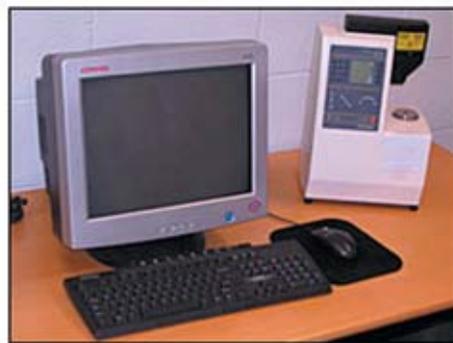
Figure 3. Computer setup for use with the Procera[®], scanning protocol using CAD/CAM technology. (Nobel Biocare USA, Inc., Yorba Linda, CA)

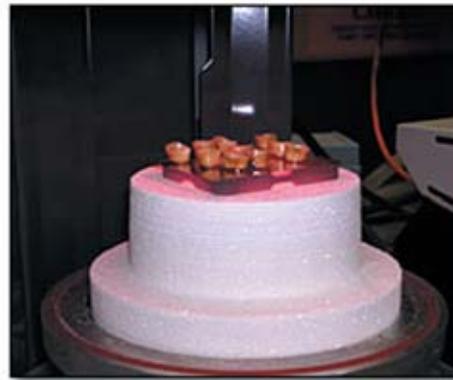
Figure 4. Hot Cerac® In-lab copings following glass infiltration process. (Sirona, Charlotte, NC)

Computerized Dentistry Unit.² Ten copings were milled from Inceram Alumina blocks (Vita) and ten from Inceram Zirconia blocks (Vita). The milled copings were then glass infiltrated as specified by the manufacturer (Figure 4). The last ten dies were sent directly to Dental Art Laboratory of Lansing, MI for fabrication of IPS Eris, lithium disilicate copings (Ivoclar/Vivadent Inc., Amherst, NY) using the lost wax, pressed glass technique.³ Upon completion, all copings were visually inspected under 2.5x magnification and matched to their specific titanium die (Figure 5).

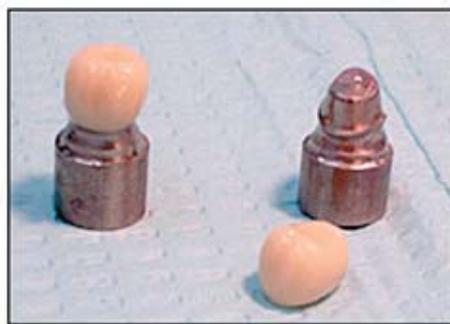
Figure 5. All ceramic crowns matched with respective dies.

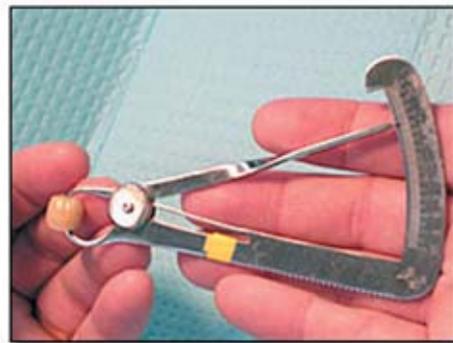
Figure 6. Crowns being measured for thickness on the center of the buccal, occlusal, and lingual surfaces.

Additionally, the technician was instructed to keep the porcelain and coping thickness standard for all fifty samples. Upon completion of the crowns, all samples were visually inspected under 2.5x magnification, measured for thickness on the center of the buccal, occlusal, and lingual surfaces, and then matched to their specific die (Figure 6).

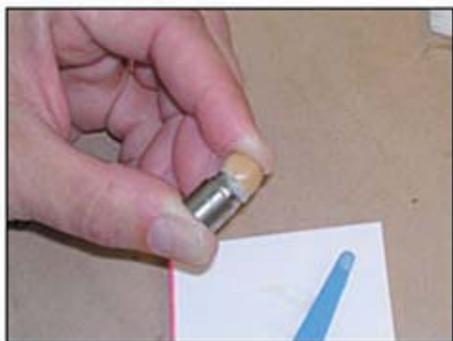
Figure 7. Crown luted to a titanium die.

All of the crowns were then luted to their respective titanium die using G.C. Link Max resin adhesive cement. The cement was mixed according to the manufacturers' instructions and placed into the crowns with a sponge-tip applicator. The crowns were then luted to the titanium dies (Figure 7).

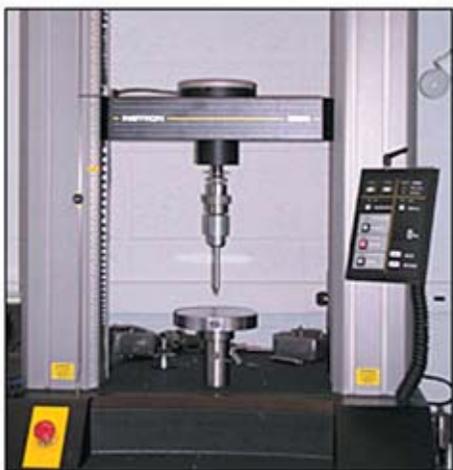
Figure 8. An Instron (Instron Corporation, Canton, MA) universal testing machine.

The samples were then loaded to fracture at the rate of 0.5 mm/min using an Instron (Instron Corporation, Canton, MA) universal testing machine (Figures 8 and 9).

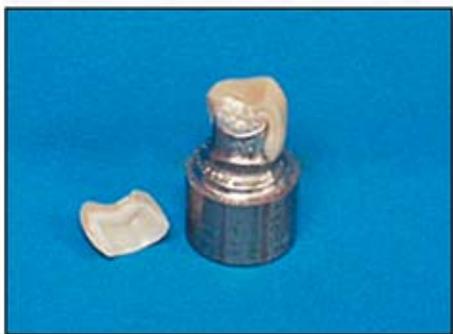
Figure 9. Fractured crown on titanium die.

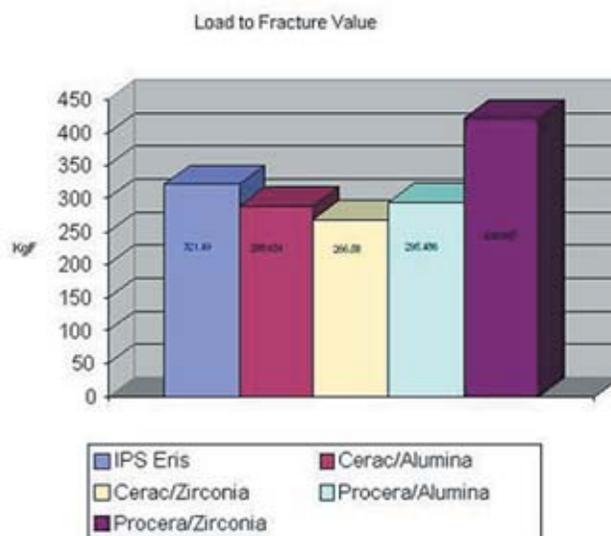
Figure 10. Load-to-fracture values.

In this study fifty all-ceramic crowns were divided into five groups of ten samples each based upon their crown system and coping type. The crowns were luted to titanium dies using G.C. Link Max resin cement. The crowns were loaded to fracture and the load-to-fracture value was obtained for each sample. The mean load-to-fracture value for each group is as follows: (Figure 10 and Table 1)

- Group A = 321.49 KgF ± 113.69 (S.D.)
- Group B = 288.63 KgF ± 102.82 (S.D.)
- Group C = 266.58 KgF ± 102.82 (S.D.)
- Group D = 295.49 KgF ± 80.54 (S.D.)
- Group E = 420.37 KgF ± 82.45 (S.D.)

Statistical significance was determined at a level $P \leq 0.05$. The unpaired t-test was applied to the data, which indicated there was a statistical difference between Group E (Procera/Zirconia) and all of the other groups. All of the remaining groups were not statistically different.
