A Comparison of Two Different Methods and Materials Used to Repair Polycarbonate Crowns

Citation: Yilmaz A. A Comparison of Two Different Methods and Materials Used to Repair Polycarbonate Crowns. *J Contemp Dent Pract* 2007 February;(8)2:0105-112.

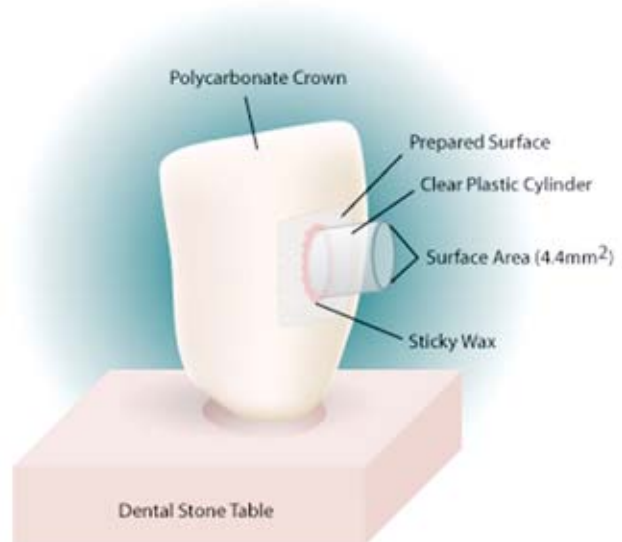
Figure 1. Assembly for shear bond strength testing.

Groups 1 and 2. An adhesive agent (Prime & Bond 2.1, Dentsply, DeTery GmbH D-78467, Konstanz, Germany) was applied to the prepared surface for 30 seconds. Any excessive adhesive agent was gently removed with oil-free compressed air and then light-cured for ten seconds. A clear plastic cylinder with a surface area of 4.4 mm² was placed over the adhesive covered surface and secured with sticky wax (Figure 1).

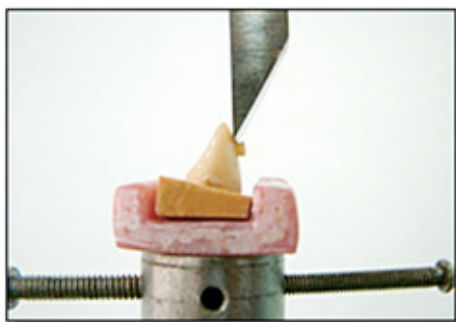
Figure 2. Assembly for shear bond strength testing.

Each specimen was placed into a mechanical testing machine (Hounsfield, Test Equipment, Raydon, England). Shear force was applied using a knife-edged blade, applied parallel to the bonding surface of the polycarbonate crown at a crosshead speed of 1.5 mm min⁻¹ (Figure 2).

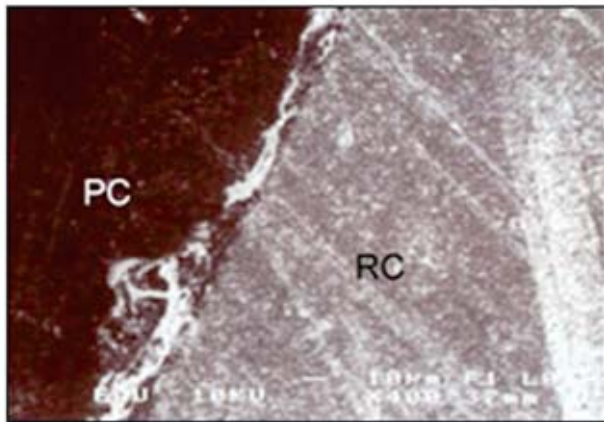
Figure 3. Interface Tetric Flow-polycarbonate crown. There are some separations along the interface (PC, polycarbonate crown; RC, resin composite; Original magnification X400)

In Groups 1 and 2, SEM micrographs (Figures 3 and 4) revealed polycarbonate crown-repair material interfaces had some separations.

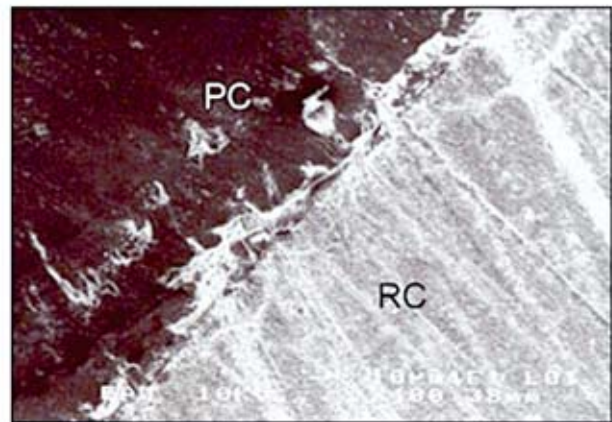
Figure 4. Interface Valux Plus-polycarbonate crown. There are some separations along the interface (PC, polycarbonate crown; RC, resin composite; Original magnification X400)

bond strength than Valux Plus (a hybrid resin composite) in all groups. However, no significant difference was found between both Groups 1 and 2 and between Groups 3 and 4 ($P > 0.05$). The probable reasons for this might be flowable resin composite, due to their thixotropic qualities, could better adapt to tiny crevices and voids that are difficult to enter and with fewer air bubbles emerging during the application.¹⁸ SEM micrographs (Figures 3 and 5) supported the explanations. The micrographs shown in Figures 4 and 6 were not a close adaptation between polycarbonate and the repair material.

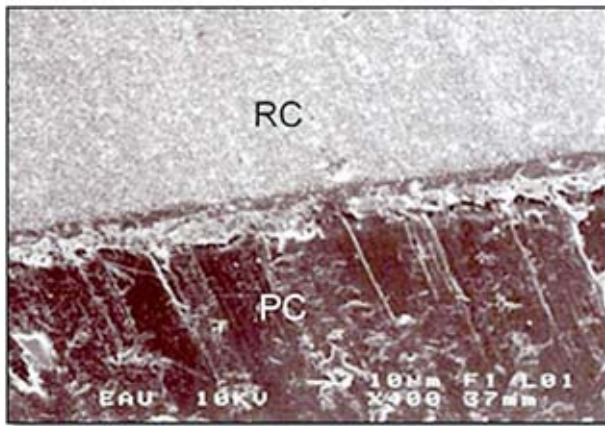
Figure 5. Interface between Teric Flow-polycarbonate crown treated with MMA monomer. There is intimate adaptation between both of those (PC, polycarbonate crown; RC, resin composite; Original magnification X400).

Grooves between the crown and repair material were not observed in either micrograph. Figure 5 (Group 3) showed an intimate relationship between the polycarbonate crown and the test material. In Figure 6 (Group 4), porosities between the polycarbonate crown treated with MMA monomer and repair material were observed.

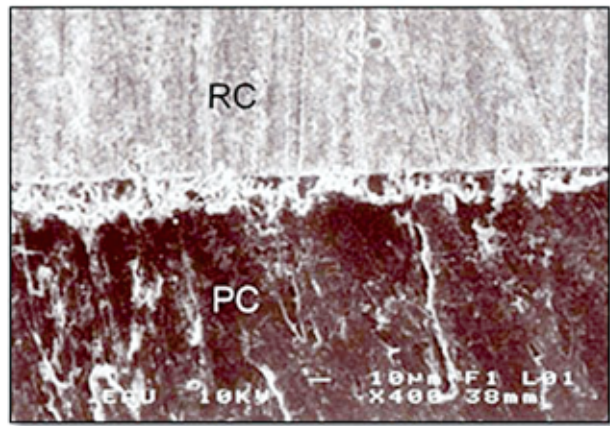
Figure 6. Interface between Valux Plus-polycarbonate crown treated with MMA monomer (PC, polycarbonate crown; RC, resin composite; Original magnification X400).
