## Biomechanical Aspects in Late Implant Failures: Scanning Electron Microscopy Analysis of Four Clinical Cases

**Aim:** The aim of this work is to analyze by scanning electron microscopy implant components that have mechanically failed *in vivo*.

**Materials and methods:** Three clinical cases are presented relative to single lateral posterior restorations supported by implants and a case of a mandibular overdenture supported by two implants. In all the reported cases the presence of an incongruous occlusal load caused the fracture of the components of the implant supported restorations.

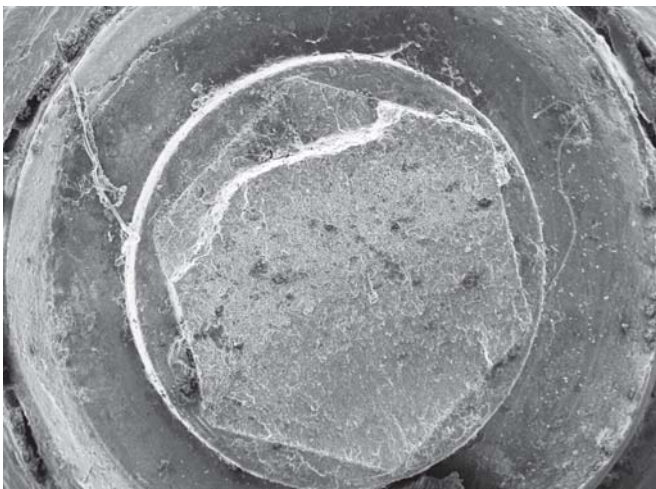
Fig. 5: SEM imaging (45x) of a crown prosthesis fractured at the fixture connection

In this case, restoration is performed in a 51-year-old male patient. Single crown element 3.6. The prosthesis fractured in correspondence to the neck of the fixture after 13 months use. The presence of an incongruous occlusal load, in association with a mechanical failure determined the fracture of the connecting screw due to strain (Figs 5 and 6).
