Removal of a Fractured Locator Abutment Screw Fragment

Ilser Turkyilmaz, Matthew Joseph Vierra, Neset Volkan Asar

How to cite this article: Turkyilmaz I, Vierra MJ, Asar NV. Removal of a Fractured Locator Abutment Screw Fragment. *J Contemp Dent Pract* 2013;14(5):968-972.

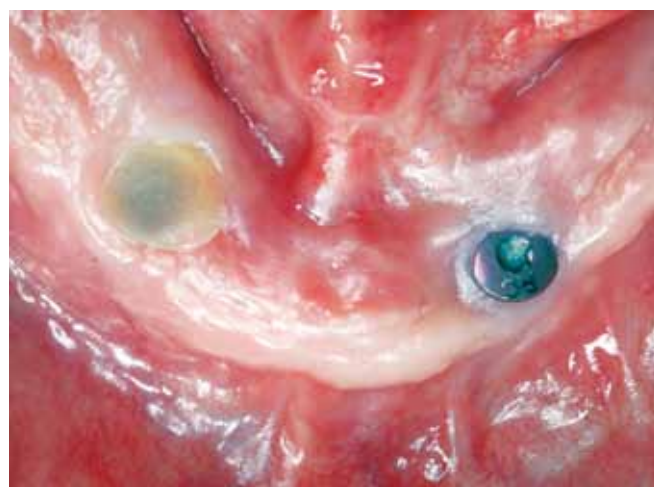
Fig. 1: Patient with fractured locator abutment covered with temporary restorative material

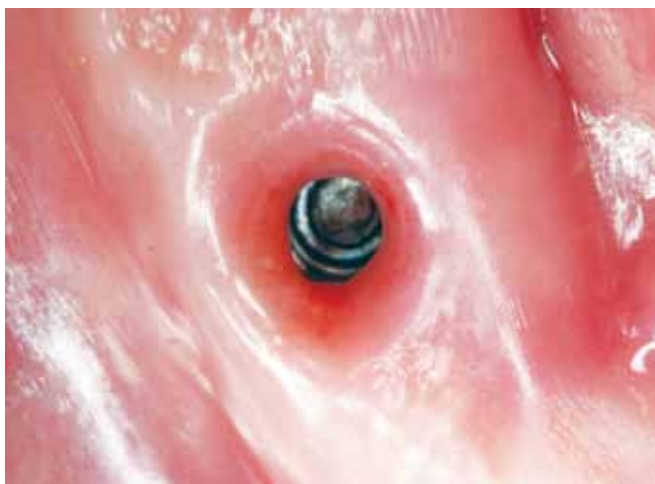
Fig. 2: Fractured locater abutment screw fragment in the implant screw hole

occurred when he torqued it with 50 Ncm. The locator abutments should not be torqued with more than 30 Ncm. Clinical and radiographic examination revealed a fractured locator abutment screw associated with a bone-level implant (4.1 × 10 mm, ITI Dental Implant System; Institute Straumann AG, Waldenburg, Switzerland)) (Figs 1 and 2). Clinical access and visibility were compromised as only about 2 to 3 mm of apical part of the screw was in the implant. Temporary restoration material placed by his dentist to cover the implant was removed. The implant screw hole was flushed with an air/water spray, and dried with air for better access and visibility. The area was isolated with cotton rolls and implant threads were evaluated for damage. Attempts to remove the fractured fragment using a periodontal probe and a manual screw removal driver were unsuccessful (Fig. 3).

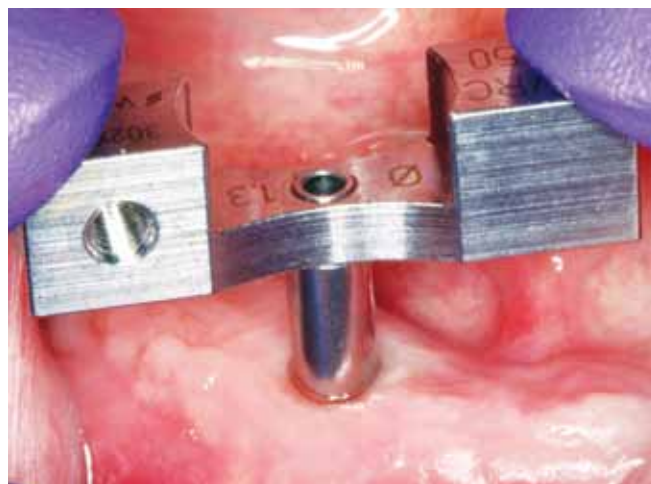
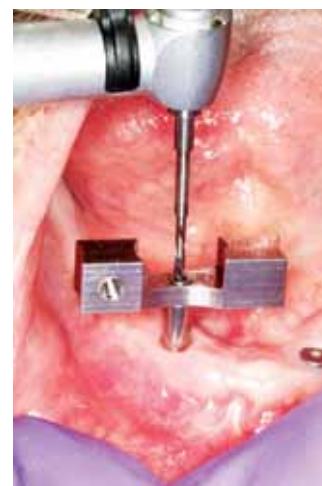
Fig. 4: Drill guide seated on the implant

Fig. 5: Drill used to perforate fractured locater abutment screw fragment

After the first drill guide was inserted on the implant, the corresponding initial twist drill with diameter of 1.3 mm was used to perforate the screw fragment centrally, rotating clockwise at a maximum speed of 800 rpm under copious irrigation with standard saline solution (Figs 4 and 5). The drill guide was stabilized in position directly on the top of the implant to allow strong axial preparation, which helped to not damage the internal aspect of the implant body during drilling. The manual tapping instruments to retrieve the fragment were coated with vaseline and inserted into the hole drilled into the fragment through an additional larger diameter guide (Figs 6 and 7). The fragment was taken out under gradual manual rotation (Figs 8 and 9). If the threads inside the implants are damaged, they are recut with the successive manual tapping instruments. The inner wall of the implant body was rinsed with saline solution and evaluated thoroughly. The implant screw hole was flushed with an air/water spray, and dried

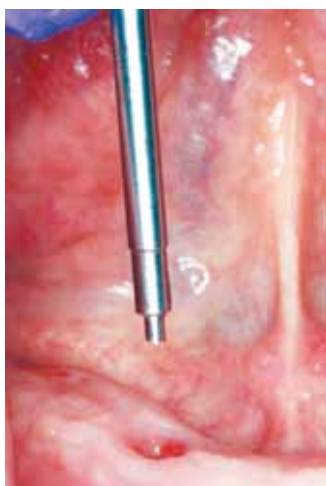
Fig. 3: Manual screw removal driver

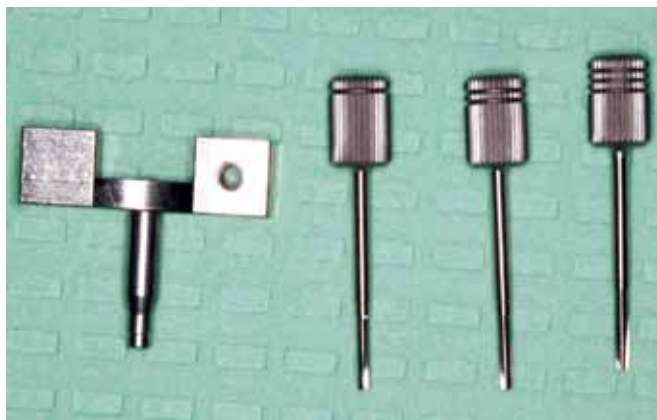
Fig. 6: Drill guide and tapping instruments

An implant repair kit (ITI Dental Implant System; Institute Straumann AG, Waldenburg, Switzerland) including an initial drill, 2 instrument guides, and 3 manual tapping

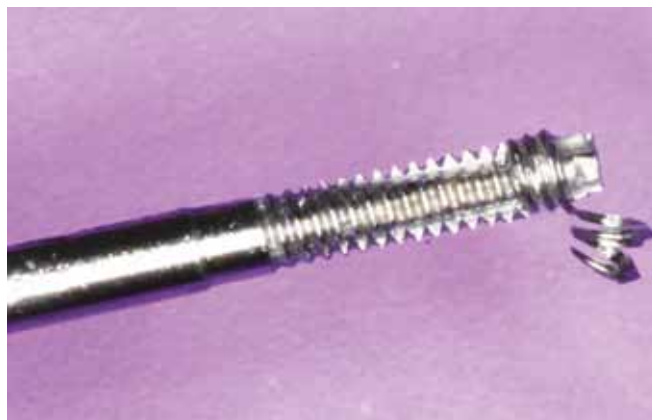
Fig. 8: Remaining fractured locator abutment screw fragment removed

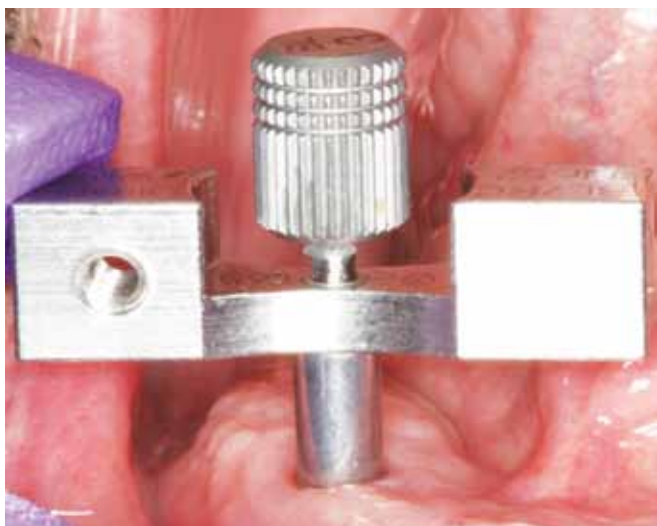
Fig. 7: Tapping instrument used with drill guide

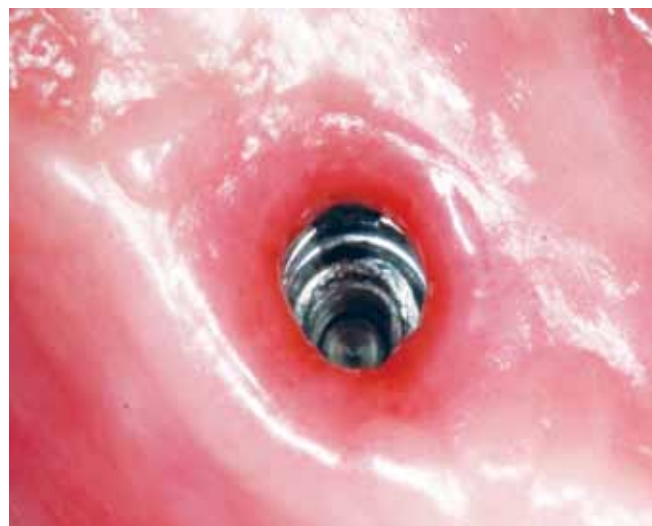
Fig. 9: Implant screw hole after fractured locator abutment screw fragment removed

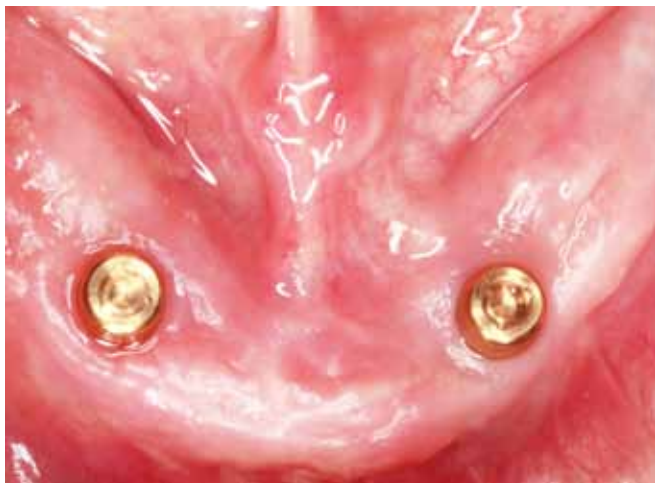
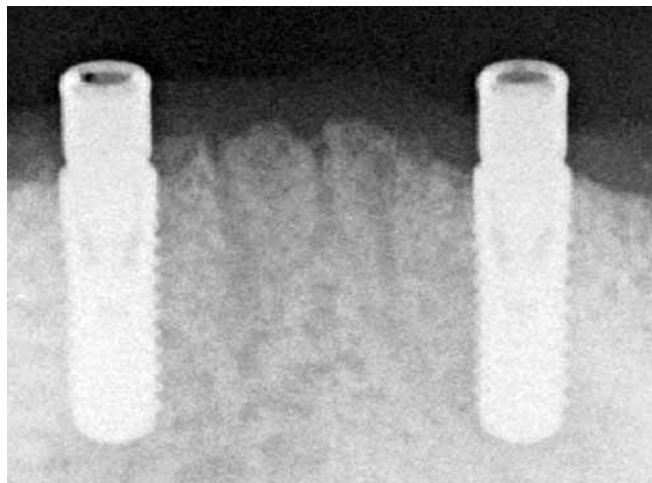
Fig. 10: Intraoral view after new locater abutments inserted

Fig. 11: Periapical radiograph taken after new locater abutments screwed

with air. A new locater abutment was inserted on the implant and tightened with 30 Ncm of torque (Figs 10 and 11). The implant has been salvaged and the patient returned to her dentist for a mandibular overdenture treatment.
