CASE REPORT

Hemisection: A Treatment Option for an Endodontically treated Molar with Vertical Root Fracture

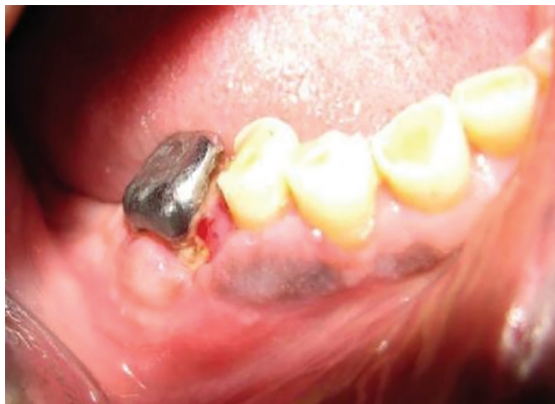
Fig. 1: Preoperative view— intraoral swelling observed

A male patient aged 60 years, with history of pain swelling in a lower molar (Fig. 1). History of mild pain on chewing in relation to the same, with history of root canal treated tooth in relation to the same 10 years back. The patient indicated there was pain and was willing to retain the tooth. On intraoral examination, there was swelling in 46 in the buccal aspect (Fig. 1). Exudation was noted from the sulcular area. The distal root was in good condition with alveolar bone loss. There was no trauma from occlusion radiographically, the fracture line was not very clear. Antibiotics and analgesics were prescribed and the patient was explained the prognosis. The surgical procedure was explained and scheduled. Patient’s consent was obtained. For hemisectioning of the tooth,

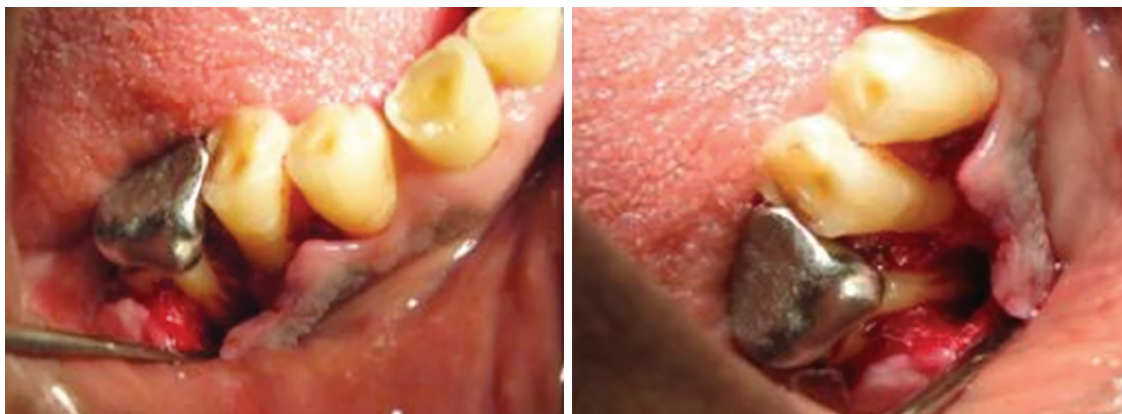
Fig. 2: Surgical view— full thickness flap raised, vertical fracture line in the mesial root of 46 extending from CEJ to the apex, bone loss seen around the same

a surgical approach to visualize the furcation area is the most predictable technique. After anesthetizing, a full thickness periodontal flap was elevated to visualize the defect. A vertical fracture line was extending from the CEJ (cervico enamel junction) to the apical 3rd An angular type of bone loss was present (Fig. 2). Hemisectioning of the tooth was performed and the fractured root fragments along with the crown portions were removed (Fig. 3). Hemisectioning of the tooth was performed and the fractured mesial root fragment was performed with a diamond bur. The tooth was carefully sectioned and the fractured mesial fragment was removed. Any defects on the sound distal root were smoothed. After the bioactive glass (perioglas) bone graft material was placed and sutured. Postoperative instructions were given. The patient was prescribed antibiotics and analgesics. Patient was recalled after a week for suture removal. The next phase of the treatment schedule involved the restoration of the hemisected tooth with a provisional crown. Final prosthesis was given after 3 months. A full metal prosthesis with extension on 45 was designed. A trial was done. With the patient’s consent, the prosthesis was cemented (Fig. 4). Patient was re-called for re-evaluation after 1, 3, 6 months, 1 and 3 years (Figs 5A and B). The patient did not report any complaints/ discomfort. The surgical area healed uneventfully. At each visit, the patient/s oral hygiene was evaluated. The patient reported once in 6 months after the first year. The patient’s oral hygiene was good and was able to maintain area well and did not report any untoward complications after placement of the final prosthesis.

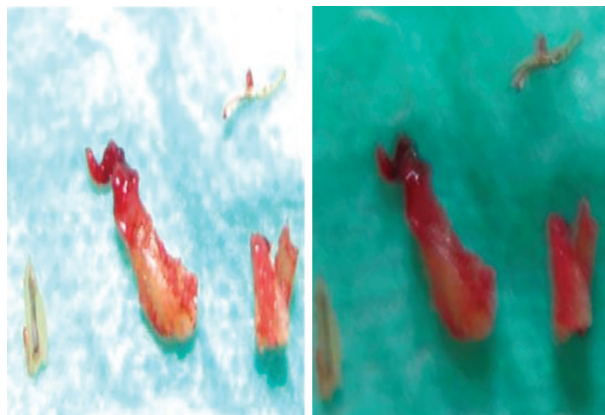
Fig. 3: Surgical—after removal of fractured segments with periapical granuloma at the apex of the mesial root

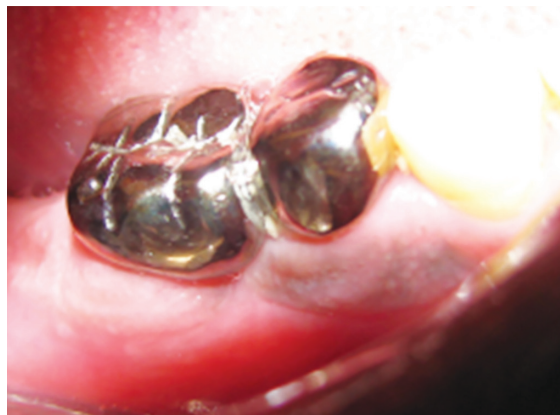
Fig. 4: Postsurgical. One-year follow-up. Fixed partial prosthesis in relation to 45, 46

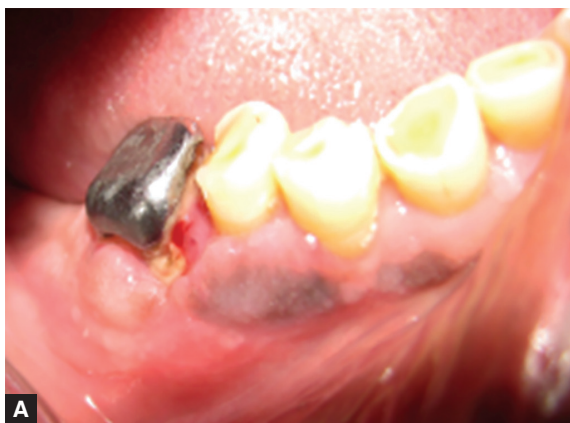
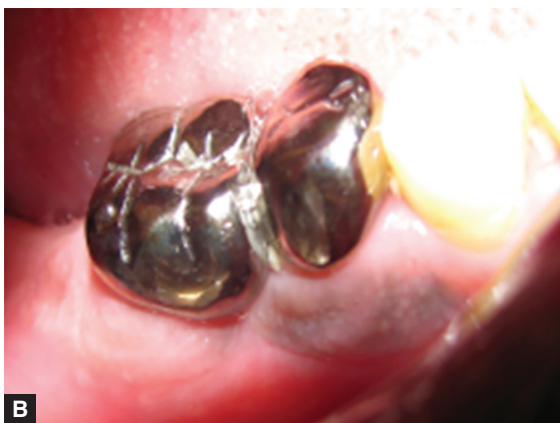
Figs 5A and B: Comparison of presurgical and postsurgical (2 years follow-up)
