# CBCT Performance and Endodontic Sealer Influence in the Diagnosis of Vertical Root Fractures

**Aim:** To evaluate the performance of three cone beam computed tomography (CBCT) machines in detecting vertical root fractures (VRFs) in teeth filled with different sealers.

*The Journal of Contemporary Dental Practice* (2019): 10.5005/jp-journals-10024-2556

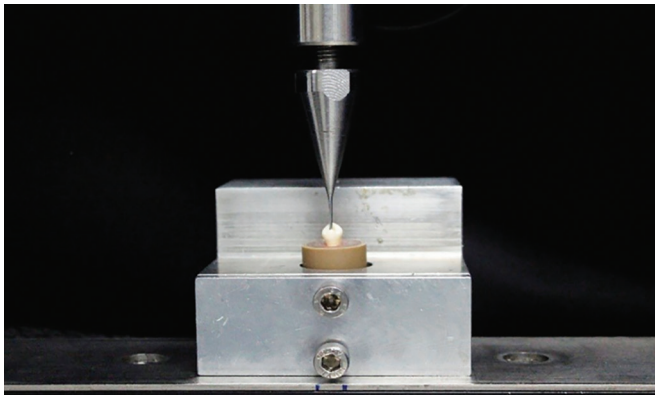
**Fig. 1:** Positioning of the test specimen in the universal mechanical testing machine

For root fracture simulation, the created test specimens of each group were mounted on a cylindrical device in a universal mechanical testing machine (EMIC DL 2000; São José dos Pinhais, Brazil). The specimens were then subjected to vertical compression by means of an active tip industrial sewing machine needle made of nickel-plated steel, specially created for this study. The fracture/crack was induced using controlled pressure vertical compression force at a speed of 1 mm/min with a load of 200 kgf, applied by the machine (Fig. 1). All the fractured teeth were inspected after removal of the test specimens by way of a direct visual approach using a stereoscopic magnifier (Tecnival SQF-F; Curitiba, Brazil) at 40x magnification for the confirmation of fracture.

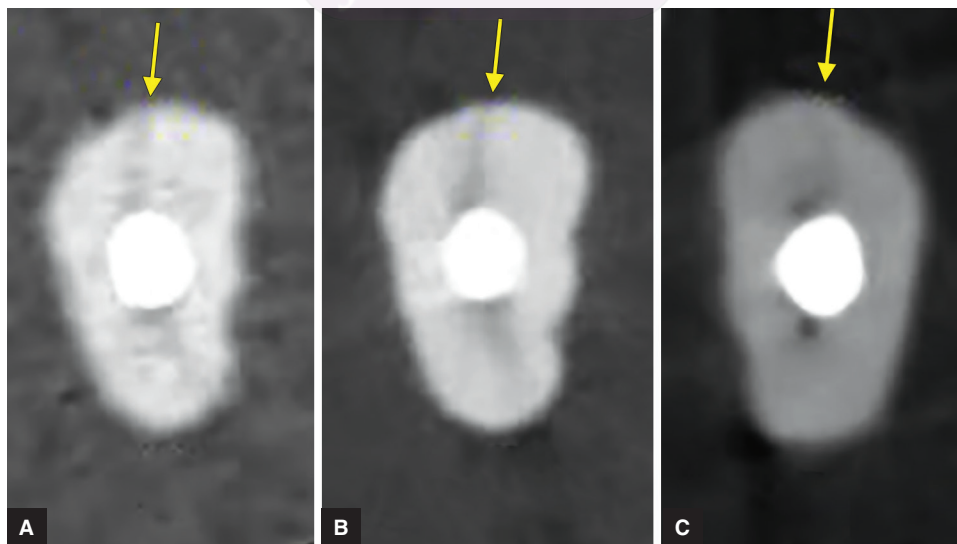
**Figs 2A to C:** Axial images showing the fracture lines (arrows) and the artifacts in the (A) i-CAT; (B) PreXion; and (C) OrthoPhos images

and other chemical substances in the formulations (bismuth oxide, bismuth subcarbonate, barium sulfate, and zinc oxide) of the various available sealers can lead to differences in density. The CBCT images show that sealers induce a greater number of artifacts that appear as hypodense lines that simulate fractures.<sup>8,16,17</sup> The different radiopacity of the sealers was found to be insufficient to exert any influence on the diagnosis of VRF ( $p > 0.05$ ) (Table 3), certainly because the volume of gutta-percha inside the canal is too high.

The dark artifact along gutta-percha simulates a fracture line<sup>17</sup> and impairs the ability to identify “true root fractures” in CBCT images,<sup>5,7,9,13-16,18,19</sup> however, three studies did not report a significant decrease in the diagnostic ability.<sup>6,13,15</sup> Different from the artifact appearance, the hypodense fracture line can be visualized at multiple planes in a fine slice reconstruction.<sup>10</sup> Elsaltani et al.<sup>6</sup> and Hassan et al.<sup>7</sup> stated that the axial section of the root is the most suitable for the detection of VRFs.

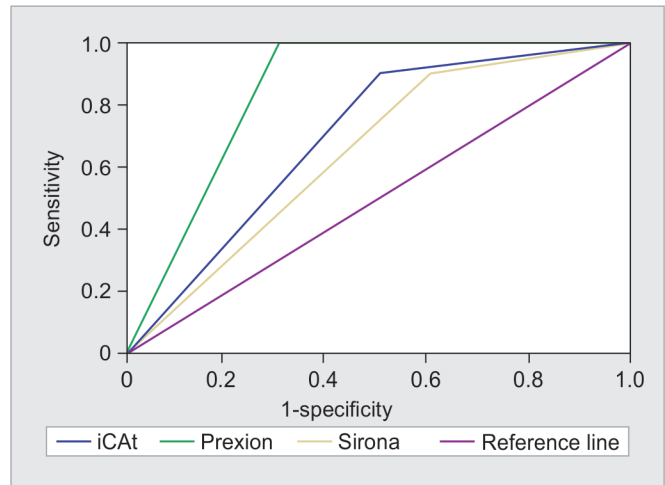
**Graph 1:** ROC curve showing the accuracy of the devices employed

Graph 1 represents the ROC curve relating to the diagnosis of root fracture in teeth filled with endodontic sealers + gutta-percha (regardless of the endodontic sealer used) and demonstrates that the greatest accuracy was obtained by using the PreXion device, with  $Az = 0.85$ . The accuracy of i-CAT and OrthoPhos XG devices was 0.70 and 0.65, indicating normal and poor performance, respectively.

According to the ROC curve, the system demonstrating a greatest accuracy was the PreXion device, with the highest proportion of true-positives and true-negatives regarding the true diagnosis, and with the area under the curve of 0.85 (good performance). It was followed by i-CAT and then OrthoPhos XG, with normal and poor performances, respectively. The good performance of the PreXion device may be attributable to its reduced voxel size<sup>10,14</sup> and lowest focal point of 0.2 mm, among the devices involved in the study. The focal point of i-CAT is 0.5 mm and that of OrthoPhos XG is 0.4 mm.
