Management of Fractured Permanent Incisors: 1 Year Follow-up

This clinical report describes the treatment of a left maxillary permanent incisor that had a complicated crown-root fracture with multiple fragments and a right maxillary permanent incisor which had an uncomplicated crown fracture. The 17-year-old female patient was presented to Ataturk University's Dentistry Faculty with posttraumatic injuries. The treatment plan included fracture segment reattachment, composite laminate veneer of the left maxillary incisor and composite restoration of the right maxillary incisor. The restorations were successful after 1-year follow-up according to the modified USPHS criteria.

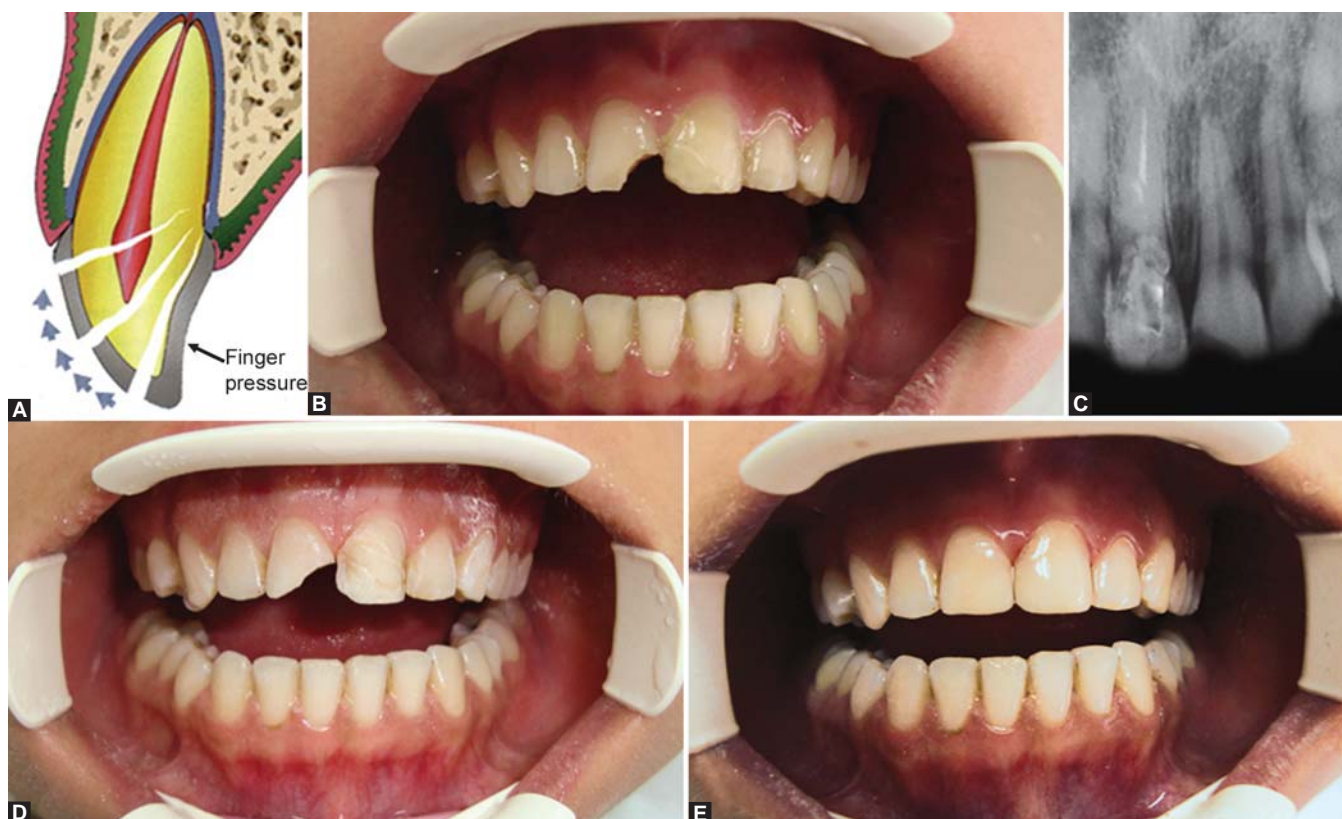
Figs 2A to E: (A) Schematic view of reattachment of fragment segments with finger pressure, (B) all fragment segments were bonded to each other with a flowable composite resin, (C) periapical radiograph of obturated root canal and fiber post, (D) preparation of teeth for restorations, (E) clinical appearance after restoration

3M ESPE, St Paul, MN, USA). The gaps in the fragments, which were already mobile, were slightly opened with finger pressure on the labial surface of the tooth. In this way, etching and bonding were applied into the gaps in the fragments. Afterwards, these gaps were filled with flowable composite. When the crown was gently pushed from the cingulum area with a finger, the fragments came together (Figs 2A and B) and polymerization was performed. Thus, the fragments of the tooth were fixed.

Then the tooth was isolated with a rubber dam and disinfected with 5.25% sodium hypochlorite (NaOCl). Standard access preparation was performed. The working length was determined by an electronic apex locator (Propex, Dentsply-Maillefer). Root canal was prepared with a HERO shaper (Micro-Mega, Besançon, France) using EDTA gel (File-Eze, Ultradent, USA) as a root canal lubricant and 5.25% NaOCl irrigation. Cleaning and shaping were considered; 1 ml of 15% liquid EDTA (Rehber Kimya, Istanbul, Turkey) for 1 minute, followed by 3 ml of 5.25% NaOCl, were used as final irrigants. The root canal was dried with paper points. The tooth was obturated by using gutta-percha, Sealapex sealer (Kerr, Italy) and lateral compaction. After the completion of endodontic treatment, root canal filling was partially removed, leaving the apical portions of the filling material to maintain a good seal. All dental surfaces were etched with 34.5% phosphoric acid (Vococid; VOCO, Cuxhaven, Germany) and a glass-fiber post (Cytec Blanco Glasfiber; Hehnenkrat, Germany) was placed in the root canal using a dual-curing luting system (Panavia-F; Kuraray Medical Inc., Okayama, Japan) prior to the application of a bonding agent (Scotchbond Multipurpose; 3M ESPE, St Paul, MN, USA) (Fig. 2C).

At the restoration stage, crown reconstruction was performed according to the laminate composite veneer technique. The labial surface of the tooth was prepared with a diamond bur (Fig. 2D). After the preparation of the tooth, 34.5% phosphoric acid (Vococid; VOCO, Cuxhaven,

Germany) and bonding agent (Scotchbond Multipurpose; 3M ESPE, St Paul, MN, USA) were applied to all prepared dental surfaces. The color of the tooth crown depends on internal as well as external crown structure. Because of the fracture lines, internal tooth color was disordered considerably. Therefore, it was impossible to perform the restoration using only one color shade of the composite resin. A dentinal shade of composite resin (Filtek Supreme XT; 3M ESPE, St Paul, MN, USA) was placed at the bottom of the restoration as a layer. Dentinal color is very opaque and it prevents reflection of the color of the fracture lines. Eventually, an approximately 1 mm thickness layer of an enamel shade of composite resin was used as a final placement, and restoration was finished. Then finishing and polishing procedures were performed with diamond burs and polishing disks (Sof-Lex; 3M ESPE, St Paul, MN, USA) (Fig. 2E).

At clinical examination, the tooth was sensitive to pressure. Pulp testing was negative, probably temporally (Fig. 1A). After clinical inspection, dental tissues were beveled with a diamond bur (Fig. 2B) to increase the bonding surface, as well as to achieve gradual transfer of the composite resin to the tooth surface and to adjust the color more easily. All dental surfaces were etched with 34.5% phosphoric acid

(Vococid; VOCO, Cuxhaven, Germany), and the bonding agent (Scotchbond Multipurpose; 3M ESPE, St Paul, MN, USA) was applied to the dental surface according to the manufacturer's instructions. Finally, the dental restoration was completed using an incremental technique with different shades of composite resin (Filtek Supreme XT; 3M ESPE, St Paul, MN, USA). Finishing and polishing procedures were performed using contouring and polishing disks (Sof-Lex; 3M ESPE, St Paul, MN, USA) (Fig. 2E).

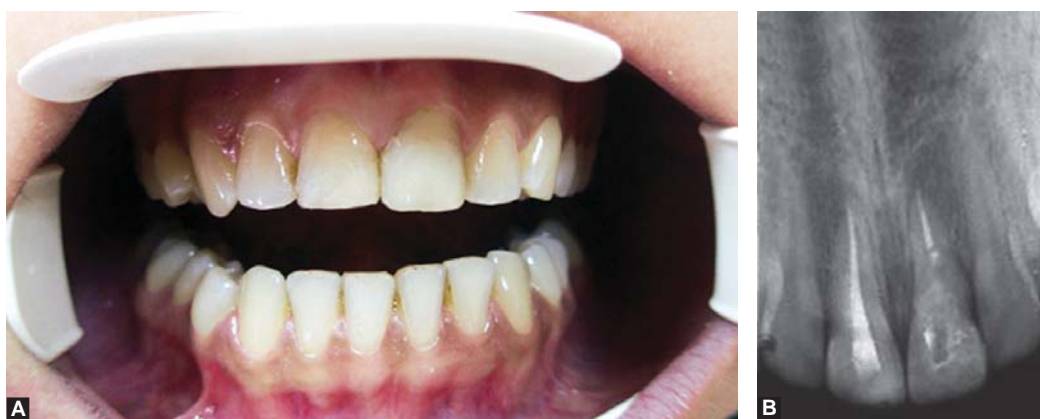
criterion there was a range of scores from Alpha (perfect) to Delta (failure). The restorations' evaluation was scored with this scale and the results were commented at three groups; clinically acceptable, functionally present or clinically unacceptable/failed by dentist. According to the evaluation results, restorations were clinically acceptable in terms of anatomic form, secondary caries, color match, retention, marginal adaptation, marginal discoloration and surface texture (Figs 3A and B).

Figs 3A and B: (A) Clinical appearance of restoration after 1 year follow-up, (B) radiography of teeth 1 year after restoration
