Do NiTi Instruments show Defects before Separation? Defects caused by Torsional Fatigue in Hand and Rotary Nickel-Titanium (NiTi) Instruments which Lead to Failure during Clinical Use

NV Murali Krishna Chakka, P Ratnakar, Sanjib Das, Anandamy Bagchi, Sudhir Kumar, Lavanya Anumula

How to cite this article: Chakka NVMK, Ratnakar P, Das S, Bagchi A, Kumar S, Anumula L. Do NiTi Instruments show Defects before Separation? Defects caused by Torsional Fatigue in Hand and Rotary Nickel-Titanium (NiTi) Instruments which Lead to Failure during Clinical Use. J Contemp Dent Pract 2012;13(6):867-872.

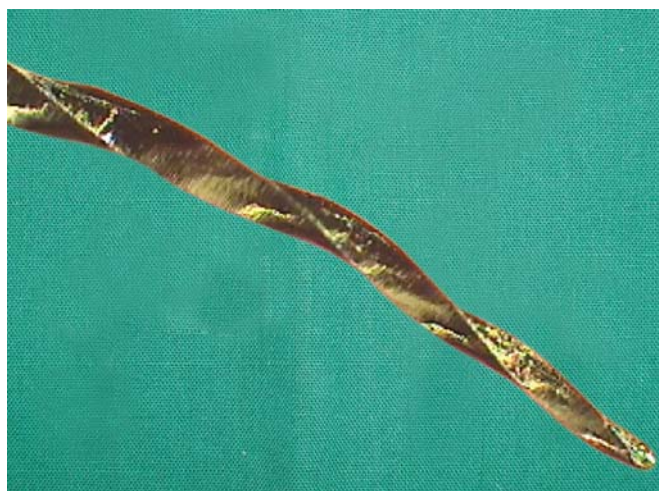
Fig. 1: Bent instrument

The percentage distribution of various types of defects as observed by different methods of examination, i.e. by visual and stereomicroscopic methods indicate that tip deformation (Fig. 2)/bent instrument (Fig. 1) was seen in 20 files (20.8%) under stereomicroscopic examination, while visual examination showed only 16 files (16.67%) with this type of defect. Stretching/straightening defect (Fig. 3) could be observed in eight files (8.3%) by stereomicroscopic examination, while the defect could be identified in six files (6.25%) by visual examination.

The overall frequency distribution of types of defects in all groups taken for observation showed that out of 96 files, 66 files (68.8%) did not show any defects. The most common type of defect was 'bent instrument', the percentage being 20.8% (20 files), this was followed by 'stretching/straightening' 8.3% (8 files) and 'partial reverse twisting' 2.08% (2 file) (Fig. 4). Other types of distortions like denting of cutting edge, change in length and fracture of the instrument were never observed.

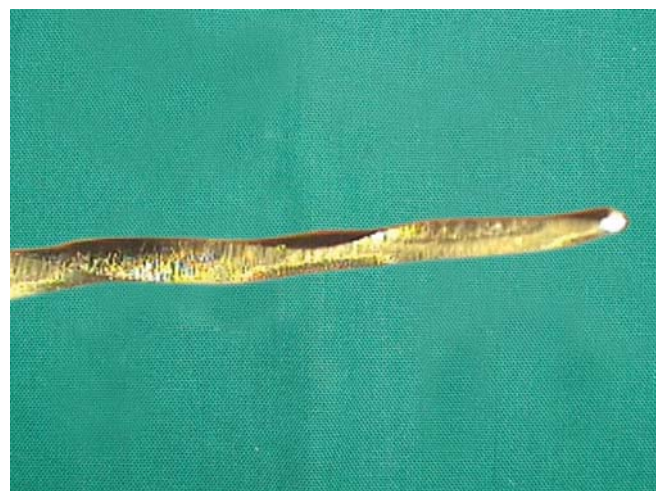
Fig 3: Straightening/stretching of twist contour

The percentage distribution of various types of defects in group II (ProTaper Rotary) showed that out of the 32 files used 81.3% (26 files) had no defects. Out of the 18.7% (6 files) distorted files, 12.5% (4 files) were bent instruments and stretching/straightening (Fig. 3) was observed in 6.3% (2 files).

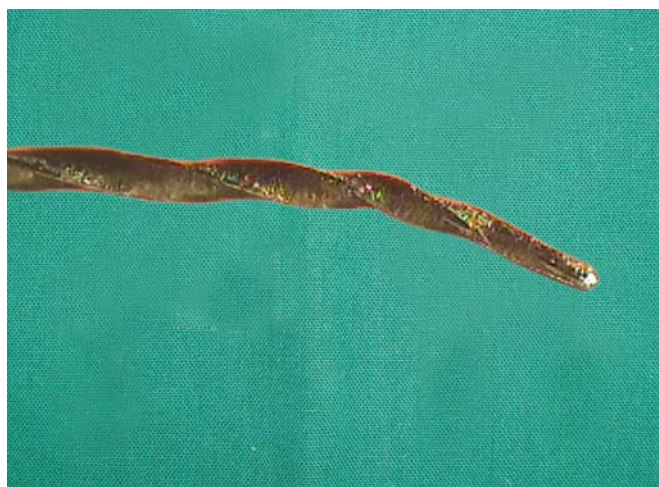
Fig. 2: Tip deformation

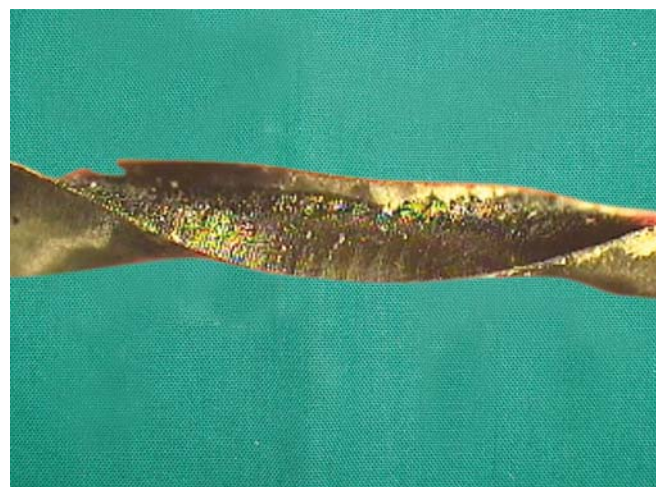
Fig. 4: Partial reverse twisting

The defect indicating severe damage (partial reverse twisting) was observed only in group I (ProTaper for hand use) which may be attributed to the difference in the manner of use between hand and Rotary files, where in the amount of pressure applied was not uniform and may be higher in case of hand instruments leading to severe damage. Sattapan (2000)⁸ stated that apical force applied was generally low (not exceeding 150 gm) when rotary NiTi files were used and in order to reduce the risk of separation due torsional failure in the root canal, apical force should be moderate during instrumentation with NiTi endodontic instruments.⁸
