## Biocorrosion of Endodontic Files through the Action of Two Species of Sulfate-reducing Bacteria: *Desulfovibrio desulfuricans* and *Desulfovibrio fairfieldensis*

**Aim:** This study assessed the biocorrosive capacity of two bacteria: *Desulfovibrio desulfuricans* and *Desulfovibrio fairfieldensis* on endodontic files, as a preliminary step in the development of a biopharmaceutical, to facilitate the removal of endodontic file fragments from root canals.

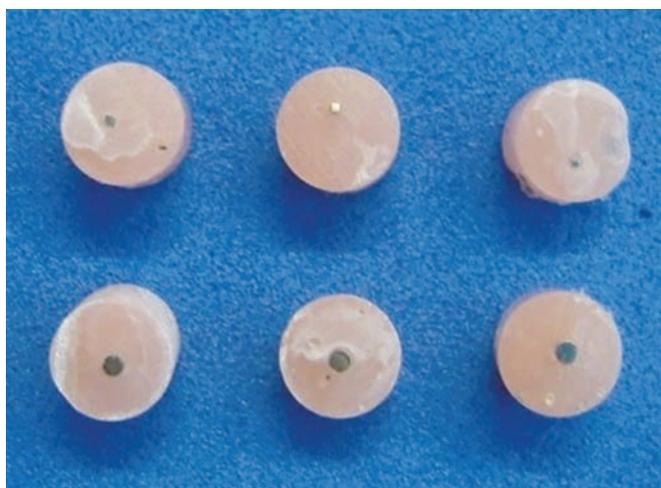
Fig. 1: Test samples

Ten Kerr n° 30 files (31 mm; LOT: 390785, REF: A 012B 0031 0030; LOT: 3776580, REF: A 012D 031 030 00 k LOT: 3776580, REF: A 012D 031 030 00) and two Kerr n° 80 files (31 mm; LOT: 1688420, REF: A 012B 031 080 00) were chosen as test samples. The endodontic files were embedded in acrylic resin for subsequent cross-sectioning by a microcut machine (Mecatome T180, Presi, France). Each test sample was sanded and polished. All test samples were observed under an infinite focus microscope (Alicona imaging, Grambach/Graz, Austria) and the obtained images were analyzed, processed and stored by a digital image processing program (Infinite focus optical 3D surface metrology). The test samples were sterilized for 20 minutes at 121°C and then used to evaluate the corrosive potential of the culture media and the species *D. desulfuricans* and *D. fairfieldensis* (Fig. 1).

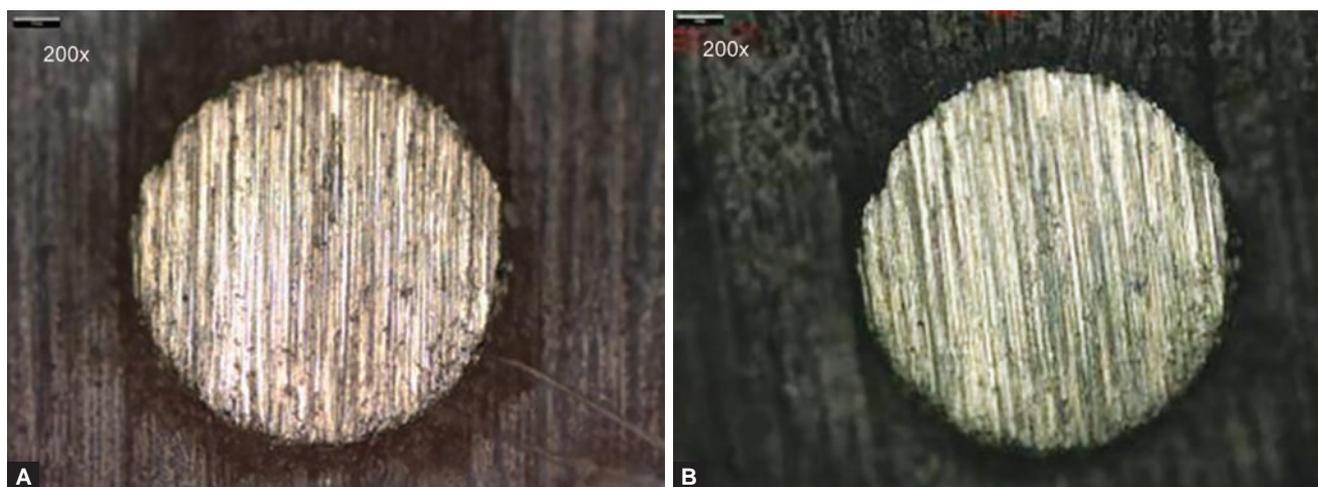
**Figs 2A and B:** A test sample from group G1 before (A) and after (B) immersion in modified Postgate E medium

A comparison of the images obtained before and after the biocorrosive test revealed that there was no corrosion of the test samples from groups G1 to G4 (Table 3). Figure 2 shows a 'before' and 'after' image of a test sample in MPECM with the absence of corrosion on the metal face of the cross-section. The test samples immersed in 2.5% sodium hypochlorite (G3) also showed no evidence of corrosion.

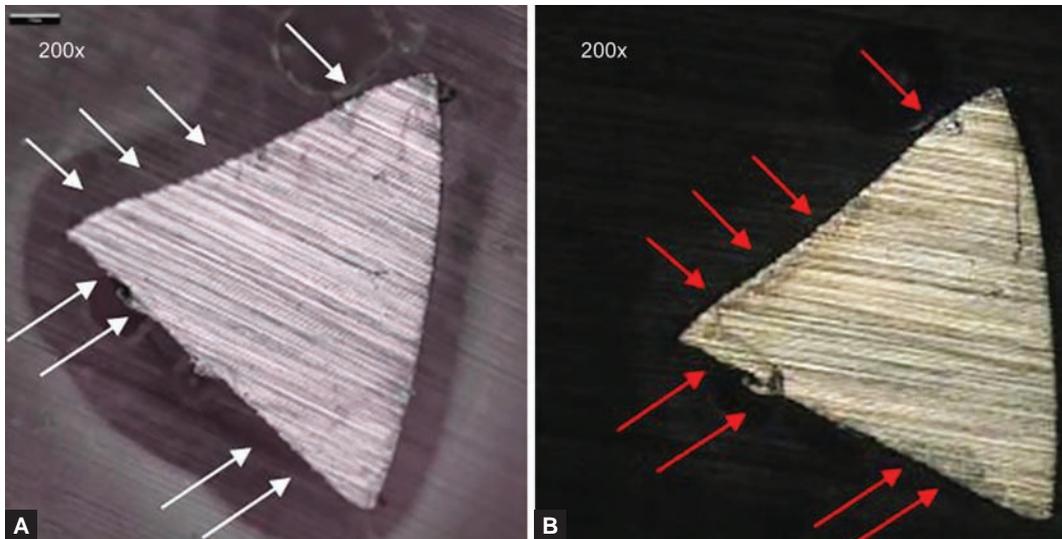
**Figs 3A and B:** A test sample from group G9 before (A) and after (B) the biocorrosion test in modified artificial saliva inoculated with *D. desulfuricans*. Indication of pits and areas suggestive of corrosion along the borders (red arrows) (B). White arrows indicate the same areas before biocorrosion (A)

The images suggesting corrosion had: (1) isolated or multiple small pits of various sizes and shapes, localized on the borders or on the cross-sectioned metal surface of the test sample (Fig. 3), and (2) extensive areas, on the border of the test samples, of visible depressions or irregular corrosion in some images, extending toward the center of the test samples and/or along the whole border (Fig. 4).

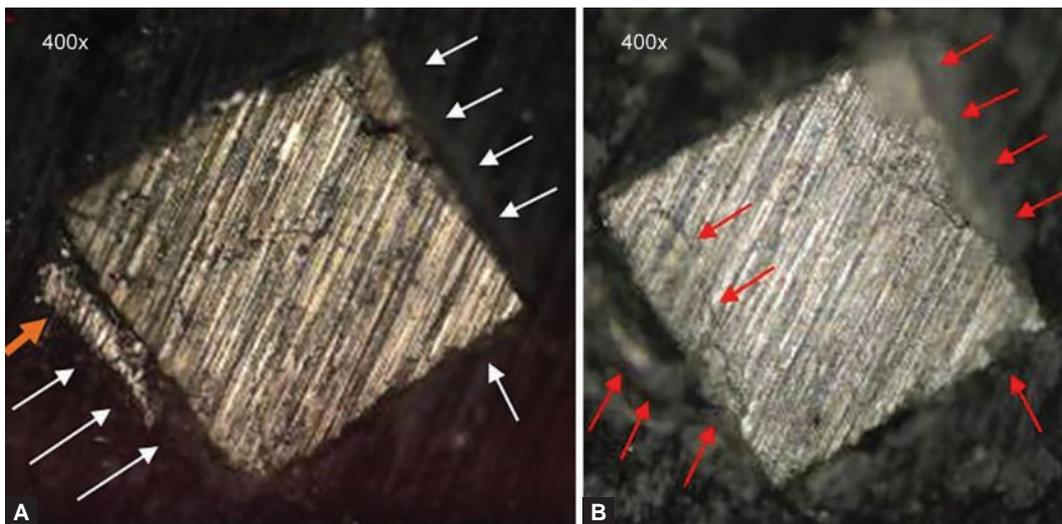
**Figs 4A and B:** A test sample from group G10 before (A) and after (B) the biocorrosion test in modified postgate E medium, inoculated with *D. fairfieldensis*. Indication of pits and areas of corrosion along the edges (red arrows) and a metal fragment that disappeared after biocorrosion (B). The white arrows indicate the same areas and the orange arrow indicates the metal fragment before biocorrosion (A)

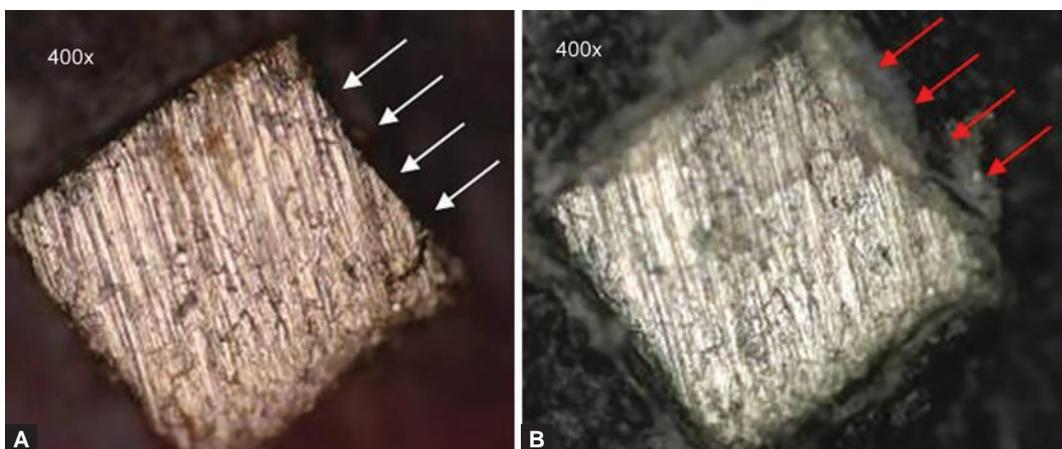
**Figs 5A and B:** A test sample from group G11 before (A) and after (B) the biocorrosion test in modified postgate E medium, inoculated with *D. desulfuricans*. Indication of pits and areas suggesting corrosion along the edges (red arrows) (B). The white arrows indicate the same areas before biocorrosion (A)

The images suggesting corrosion along the borders of the test samples were more frequent and extensive when compared to other types of corrosive defects (Fig. 5). Furthermore, in areas where the 'before' images indicated structural defects, there was the appearance of extensive areas of corrosion. The previous defects localized at the borders of the test samples were those that had the greatest corrosion, with the formation of extensive corroded areas along the borders and/or extending toward the center of the test sample (Fig. 6). Other previous defects

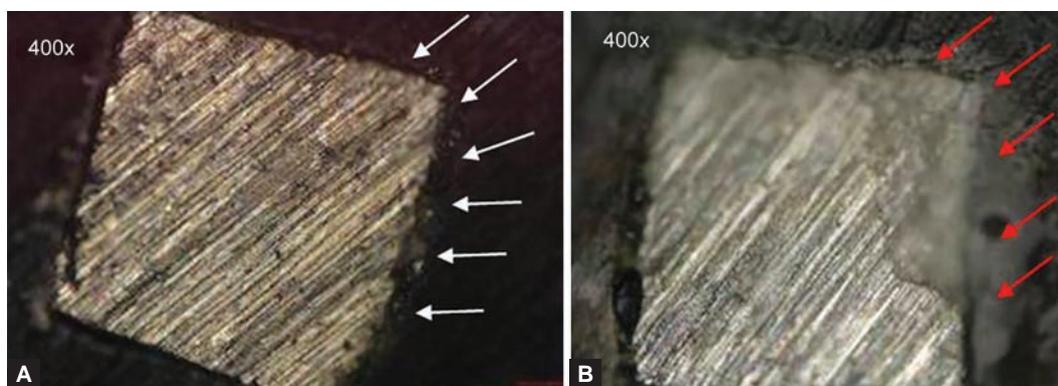
**Figs 6A and B:** A test sample from group G11 before (A) and after (B) the biocorrosion test in modified postgate E medium, inoculated *D. desulfuricans*. Indications of large areas suggesting corrosion along the edges and extending toward the center of the test sample (red arrows) (B). The white arrows indicate the same areas before biocorrosion

on the surface of the test samples also had corrosion after the assay, however, with lesser intensity as compared to areas of previous defects on the borders.
