## Comparison of the Efficacy of Three Different Instruments in the Removal of Amalgam Overhang: An *In Vitro* Study

### ABSTRACT

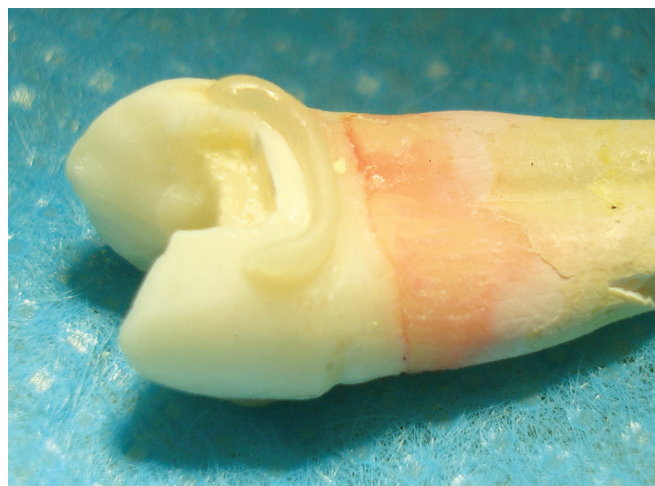
Fig. 2: Similar amalgam overhangs with an equal dimension of 1 mm

To ensure similar amalgam overhangs with an equal dimension of 1mm, the teeth were removed from the casts and LLIS composites (FGM, Joinville, Brazil) were placed around the cavities, with a diameter of 1 mm and distance of 1 mm from all margins (Figs 1 and 2). This procedure was performed using a bonding agent (FGM, Goinville, SC, Brazil) and without acid etching for ease of removal.

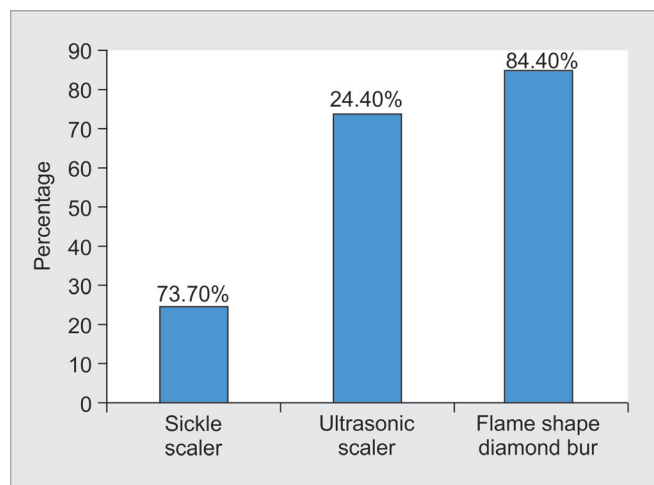
**Graph 1:** Restoration surface smoothness for each instrument

As far as the frequency distribution of restoration surface smoothness in the three groups was concerned, the resultant percentages pertinent to the sickle scaler, flame-shaped diamond bur, and ultrasonic scaler were 24.4%, 84.4%, and 73.3%, respectively ( $p < 0.0001$ ). As shown in Graph 1, the flame-shaped diamond bur method achieved a significantly higher percentage of restoration surface smoothness in comparison with the sickle scaler ( $p < 0.0001$ ) (Figs 3 to 5). A similar comparison between the flame-shaped diamond bur approach and the ultrasonic scaler showed no significant difference ( $p = 0.197$ ). However, the sickle scaler method delivered a significantly lower percentage compared to the ultrasonic scaler ( $p < 0.0001$ ).

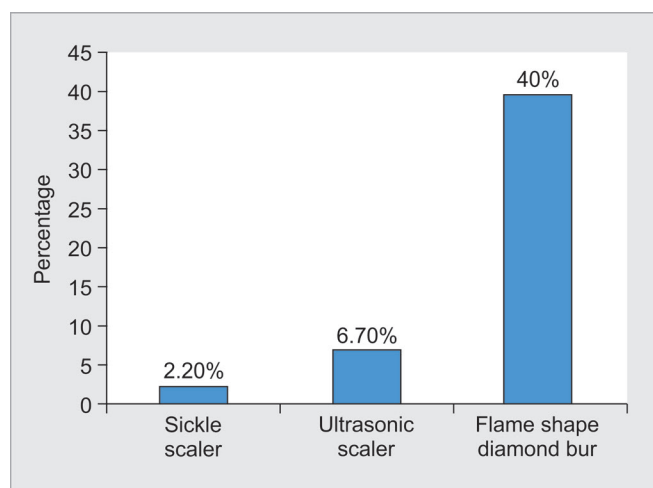
**Graph 2:** Comparison of tooth damage for each instrument

Comparison of the amount of tooth damage between the three methods is presented in Graph 2. Accordingly, the sickle scaler and flame-shaped diamond bur methods caused the lowest and highest percentages of tooth damage, respectively. The level of tooth damage was significantly higher in the flame-shaped diamond bur treatment than the other methods ( $p < 0.0001$ ). No significant difference was observed between the sickle scaler and ultrasonic scaler approaches ( $p < 0.308$ ).
